E36 POWER-STEERING HOSE FAILURES

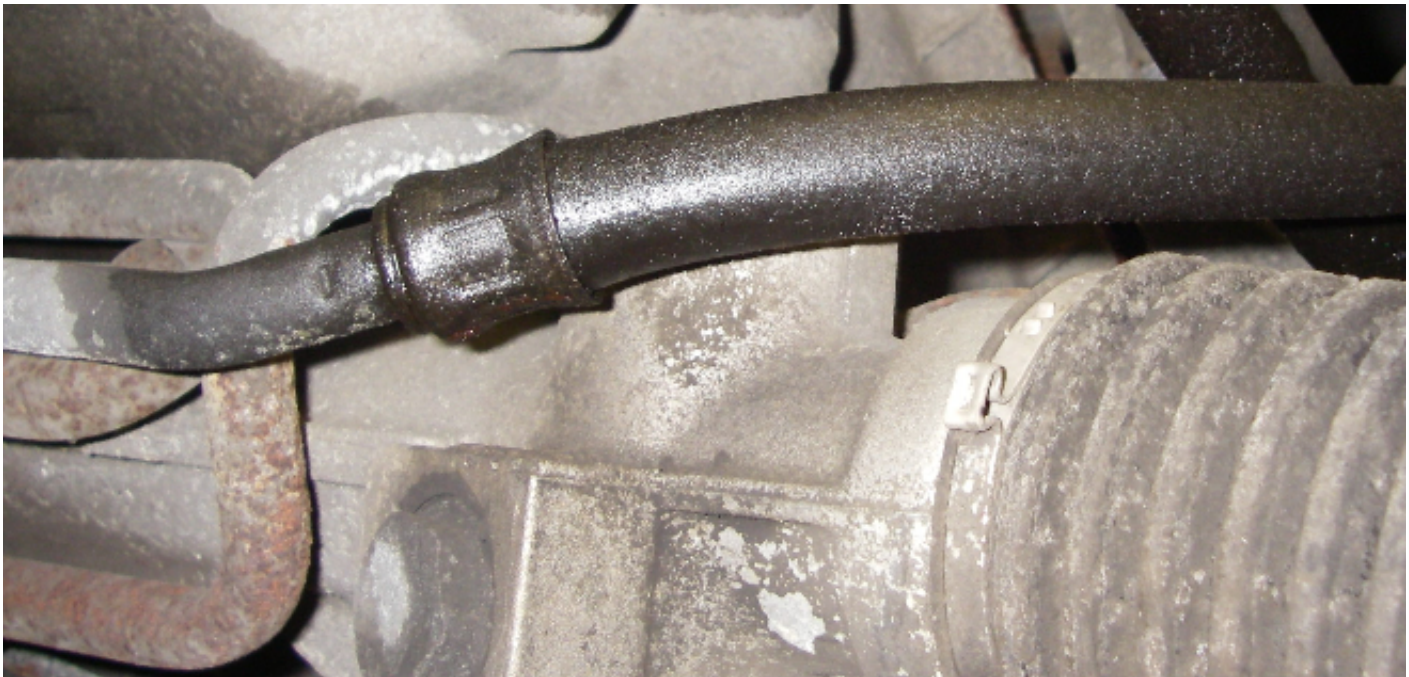
You should also seriously consider replacing the power-steering-return hose with a suitable piece of hose a few centimeters longer. BMW hose # 32-41-1-131-524 [12-mm ID (inside diameter), cut to length] is known to work in this application. You will also need two hose clamps # 11-15-1-727-509 [15-18-mm]. Some claim success with aftermarket high-temperature hose of ½-inch ID, but be advised that the BMW hose fits the nipple on the steering-cooler more tightly than do some nominal ½-inch ID hoses. In the photo, the ferrule is where the failure occurs.

Over the past couple driving seasons, we have seen a number of on-track failures of the power-steering-return hose on E36s [92-99 3-Series, including M3]. The failures we have seen were all the same: the return hose pulled off of the power-steering cooler, right at the factory-crimped connection. This failure results in the fluid content of the power-steering system being disgorged in a few seconds, creating quite a hazard on the track surface for the afflicted car and following vehicles. Of course, steering power-assist is lost as well. Why these failures did not commence earlier in the E36 life cycle remains somewhat a mystery. Please note that we have seen new, OE hose assemblies fail on their first track session, so replacing the power-steering cooler/return-hose assembly with stock parts has been shown to be ineffective in addressing the problem.

Although there is not complete consensus within the BMW-repair community as to the cause of these failures, many feel that the primary problem is that the return hose should be longer, and that engine movement [probably most severe in the on-track environment] exacerbates the problem. Deteriorated engine and/or transmission mounts can allow increased engine movement, and some feel that high temperatures may be an extenuating factor.

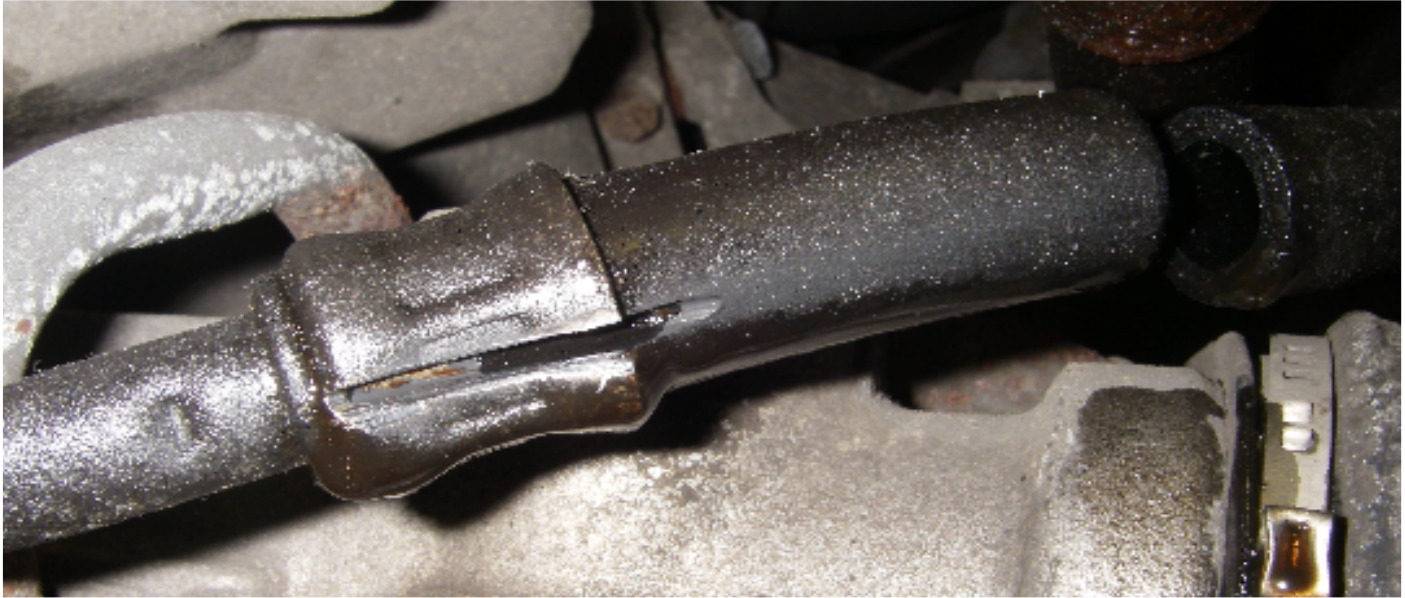
Replacing the return hose is a straightforward operation. After the car has been secured on jack stands or a lift and allowed to cool, begin by cutting the return hose and allowing the contents of the system to drain into a pan. Note that the return hose is the SMALLER of the two hoses attached to the power-steering-fluid reservoir. Then, CAREFULLY slit [as shown in the photo] and remove the ferrule/hose from the power-steering-cooler outlet. An abrasive wheel was used for the photo, but a cutting pliers will suffice. Ensure that the hose nipple under the ferrule is not damaged by the slitting operation. If it is damaged, you will need to procure a new cooler-return-hose assembly.

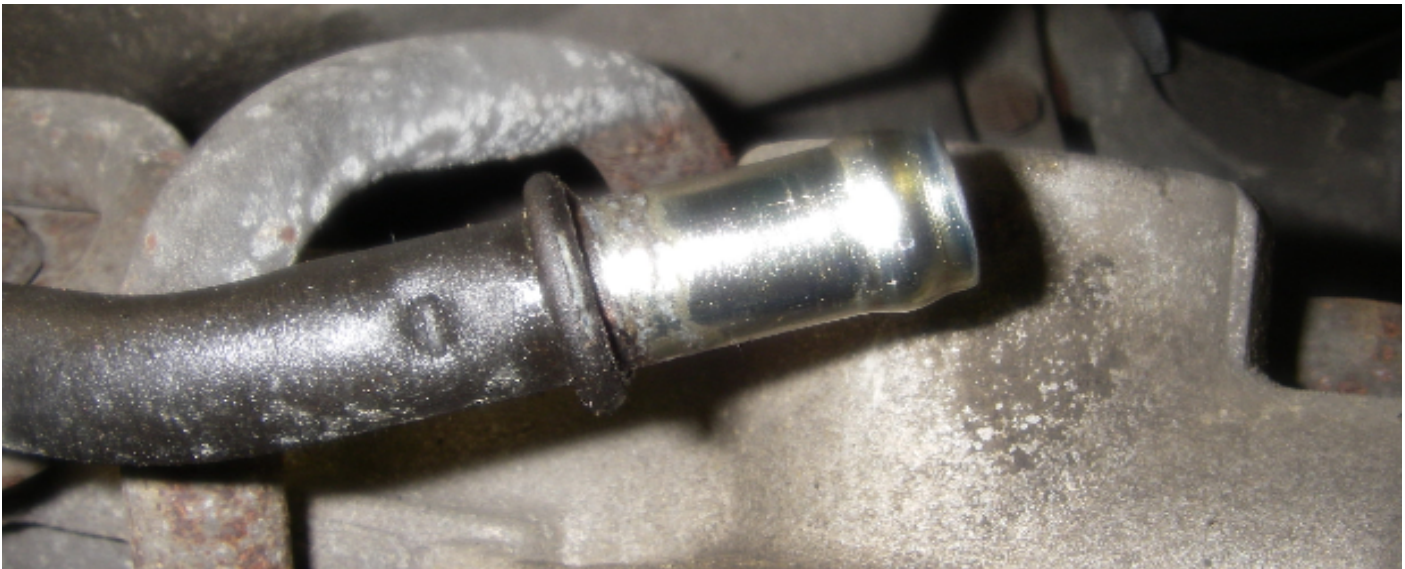
When the ferrule and hose have been removed from the cooler outlet, you should see a hose nipple like this:

Continue by removing the other end of the return hose from the power-steering-fluid reservoir, then cut the new hose to the appropriate length and install to the cooler and reservoir with two hose clamps. You may find that your removed hose contains a restriction orifice located about 10-cm from the reservoir. You can remove this orifice and push it into your new hose, securing the orifice with a third hose clamp. Refill the system with Dexron ATF or other suitable fluid and bleed the system. Check for leaks and you should be done.
